SWITCHBOARD WORK – NEAR MISS

A near miss incident has occurred at a worksite whilst a qualified electrician was preparing to inspect the bus bar to supply a MCB for a heat pump circuit. The switch board was “live” when he opened the front panel.

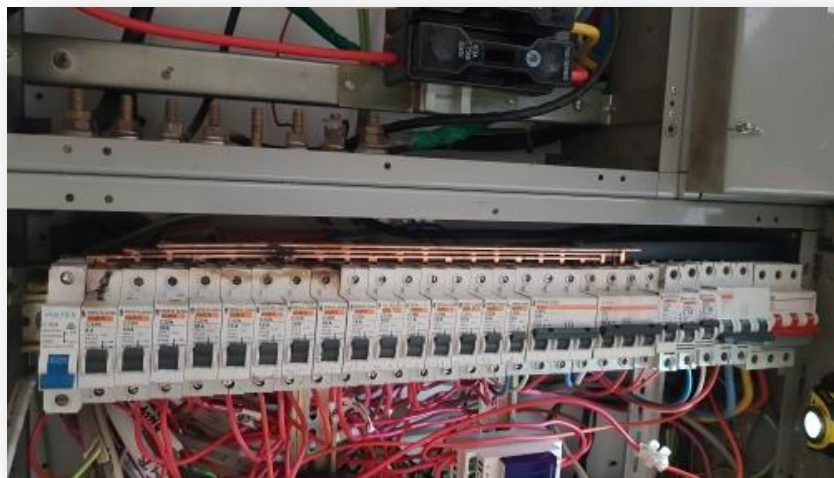
(Fig. 1)

The tech tried to remove the bus bar capping, there was an arc flash effect with a synchronised “bang” sound. As a result of this arcing, two of the main incoming HRC fuses were blown, taking out all power to the site.

The electrician did not isolate at that time for the simple fact he had not identified a spare space in the board in which to terminate cable feed for the ac circuit into a suitable breaker. No circuit legend was available at the board to reveal the breaker framework, necessitating him to remove the bus bars capping.

Burn marks and loose connections were identified on the switchboard by the electrician, these hazards were noted on the SWMS – Site Specific prior to work commencement and photographs taken (see Fig. 1).

- 1) Authorised Service Agent made the board safe tightened circuit breakers and attached LOTO devices to switch board main
- 2) Contacted clients electrical contractor to repair and reinstate power to the site

- No modification work on or behind a live switchboard by any ACS Authorised Service Agent.
- When you are applying LOTO at the board for equipment isolation perform a Last Minute Risk Assessment (LMRA). If you feel your safety is at risk, due to the condition of the board e.g. loose breakers or connections, burn marks caused by arcing, **STOP** work, contact your ACS Customer Account Manager for further instruction.
